# NON-DESTRUCTIVE DIAGNOSTICS OF BRIDGE STRUCTURES

Alexandru Cotofan, Dipl. Eng., (*Gemite Romania SRL*), Ivan Razl, Ph.D., P.Eng (*Gemite Products Inc*)  
and Spiridon Cretu, Prof. Dr. Ph.D., P.Eng. (*Technical University Gh. Asachi from Iasi, Romania*)

In the following article non-destructive diagnosis techniques are presented, together with the equipment used, interpretation methods and results from field investigations. The procedures briefly presented, which have been used to diagnose 12 bridges, include: the radar scanning with 3D imaging, the pull out test, the impact-echo technique, pH of concrete measurements, permeability and corrosion rate measurements.

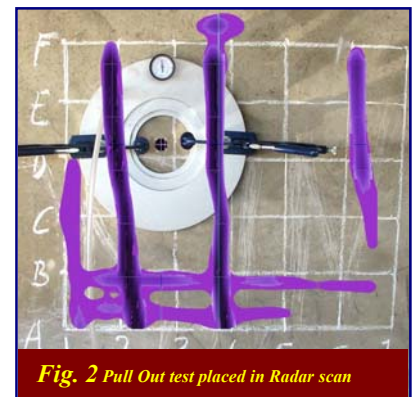
B. To precisely locate the rebar, information that allows an accurate placement of the pull out test for concrete strength measurement, (see **Fig. 2**) with a super-imposed radar image over the test area.

On each bridge we have quantified the strength of the concrete from columns and beams by using the pull-out test. The coring positions outside of the reinforcement disturbance are established by Radar scan (**Fig. 2**).

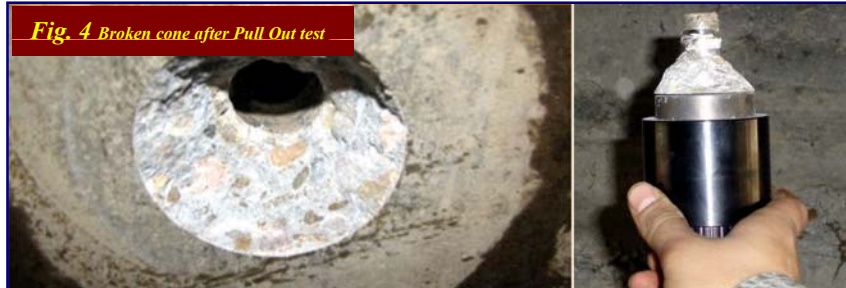
**Fig. 4** Broken cone after Pull Out test

The test is partially destructive, as it has to be performed until the cone between the expanded ring and the inner diameter of the counter pressure is dislodged (**Fig. 4**).

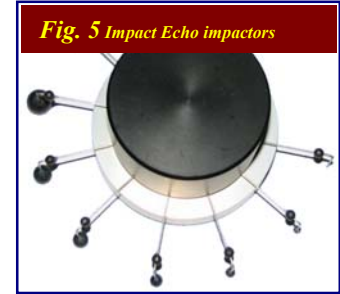
The method uses transient stress waves generated on the surface of concrete or masonry structures through a small, elastic energy impact. The energy is transmitted to concrete through an impact with a small steel ball (**Fig. 5**), whose diameter in general may vary between 1 to 24 mm, which define the wave length and consequently the fault dimensions that may be found.

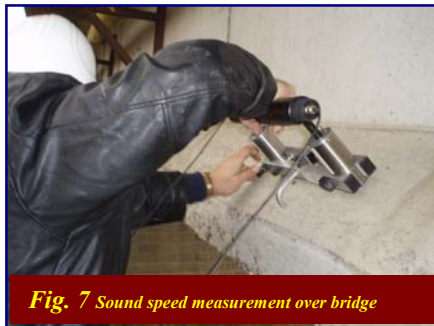
All bridge elements tested through the pull-out method were re-tested with the impact-echo technique to determine the sound speed “**C<sub>P</sub>**” (**Fig. 7**). The equipment is manufactured by GERMANN Instruments in conformance with ACI 228.2 R.

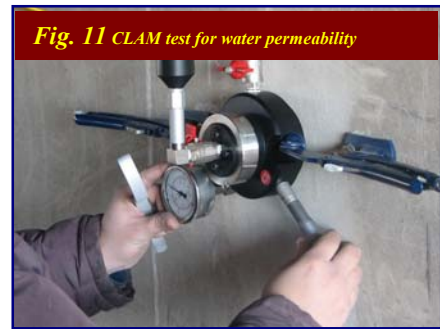
The permeability was tested with the CLAM equipment produced by GERMANN Instruments, manufactured in conformance with EN-ISO 7031 (**Fig. 11**). The concrete permeability is estimated through the permeability coefficient, in accordance with **Expression 9**.

The tests were done at 1 bar pressure. The pressure is kept constant, to compensate the water infiltrations in concrete, by adjusting the micrometer plunger. The volume of water “pushed” into the concrete is the equivalent of 25 microns plunger movement. The time needed by the water volume to penetrate, defines finally the permeability. The results are given in **Table 3**.  $C_{PB}$  is the permeability coefficient computed with the **Expression 9**.

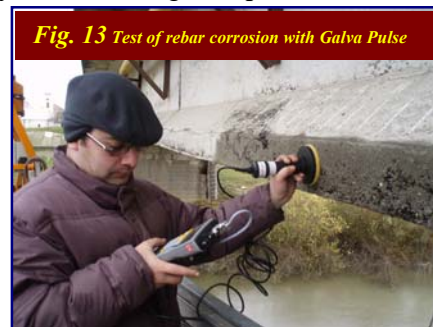
**Fig. 13** Test of rebar corrosion with Galva Pulse

The corrosion rate of steel rebar was measured using the polarization method, with the rebar acting as a working electrode. Galva-Pulse equipment manufactured in conformance with ASTM C 876, and using an Ag/Ag-Cl electrode was used for the site tests (**Fig. 13**). The equipment polarizes the steel rebar under a certain established drop of potential, and computes the corrosion loss of mass, using the Faraday law, according to **Expression 10**.

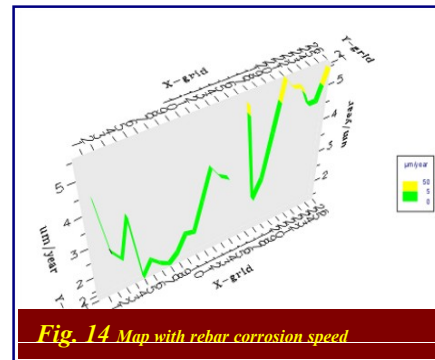
**Fig. 14** Map with rebar corrosion speed

The results are presented graphically as echi-potential maps, containing the rate (**Fig. 14**) and the corrosion probability.

No serious rebar corrosion was found, even in areas where the pH values of concrete were under pH 5.
