Waterproofing System for Wastewater Tanks in Petrochemical Industries and Refineries

Case History

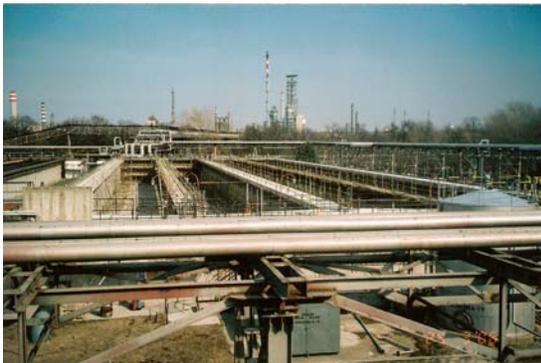
Figure 1. The first tank during the repair

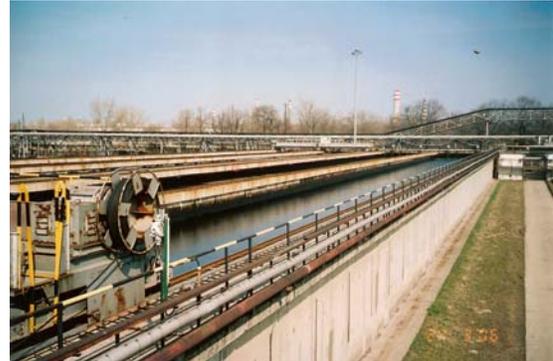
Figure 2. The second tank before the repair

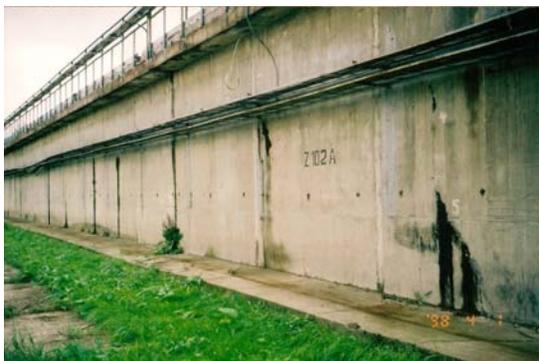
The reinforced concrete tanks have developed leaks mainly through cracks, construction joints and expansion joints. There were also leaks in areas of poor concrete compaction and in the section where the mechanical equipment was anchored in the concrete. The leaks, shown in Figure 3 present a serious ecological problem. In addition to cracks, the “low” concrete cover on steel resulted in corrosion of reinforcing steel, causing cracking, delamination and spalling of concrete as shown in Figure 4.

Figure 3. Leaks in concrete tanks

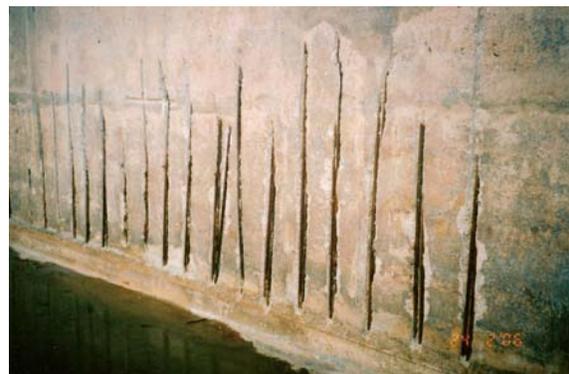
Figure 4. Delaminating concrete due to corrosion of reinforcing steel

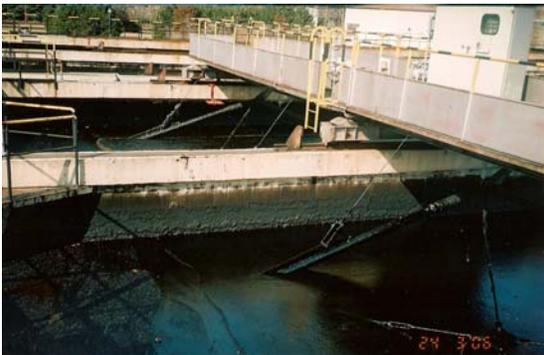
The key challenge presented in the repair and waterproofing of the reinforced concrete tanks has been “in depth” oil contamination of reinforced concrete tanks. The interior surface of concrete tanks was covered with approximately 12 – 18 mm ($\frac{1}{2}$ - $\frac{3}{4}$ in) thick layer of black oily residues, shown in Figure 5., which prevent bonding of virtually any material. Figure 6. shows the tanks after chemical cleaning. The further challenge was to span the existing moving cracks. The cracks and expansion joints move due to temperature changes and, to some extent, by the varying hydrostatic head in reinforced concrete tanks.

Figure 5. Oil and grease deposits on the surface of concrete tanks

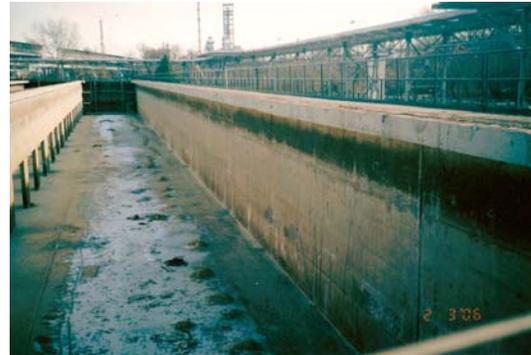
Figure 6: The surface of the tanks after chemical cleaning

The layer of hydrocarbon deposits were first removed by mechanical scraping. This was followed by high-pressure water washing (approximately 3,500 psi–24 MPa) in combination with a heavy-duty industrial detergent. The cleaning procedure consisted of two steps. The detergent was first spray applied and left to act for approximately 30 minutes. This was followed by a thorough high-pressure hot water wash. The surface of concrete after chemical cleaning is shown in Figure 6. The final cleaning was done by sandblasting shown in Figure 7, and a high-pressure wash. In some areas, at the water level, several days after sandblasting and washing, the emulsified oil from within concrete was released to the surface by capillary pressures, shown in Figure 8. These areas were cleaned again using detergent and the high-pressure water wash. In such cases, it was important to apply the bonding agent immediately after cleaning, to develop bond before additional emulsified oil, see Figure 8, was released to the surface.

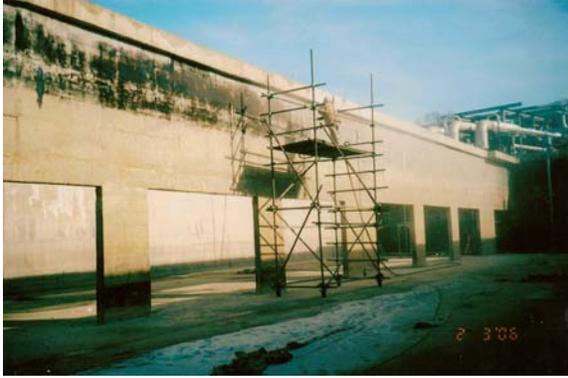
Figure 7. Sandblasting after chemical cleaning

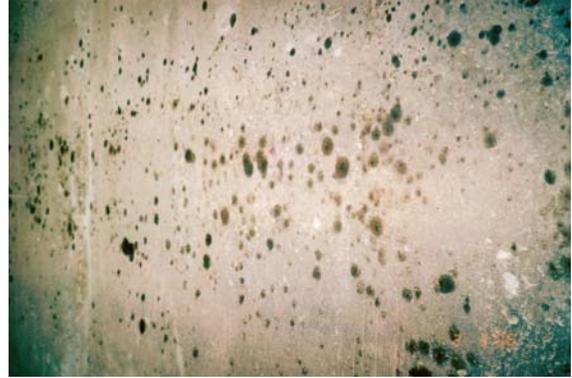
Figure 8. Residual emulsified oil “seeping out” of capillaries after sandblasting and high-pressure wash

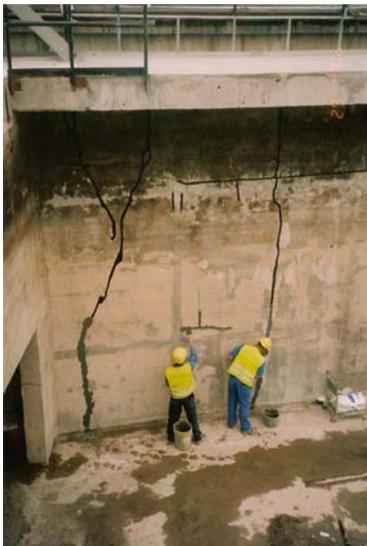
Figure 9. Filling the routed cracks with one component polyurethane

All cracks exposed by cleaning were cut and “routed out” with a chipping hammer to form a “groove”, approximately 2 cm ($\frac{3}{4}$ in) wide and 12 mm ($\frac{1}{2}$ in) deep. The crack was grind into depth of approximately 12 mm ($\frac{1}{2}$ in) and filled with one component polyurethane. The polyurethane was also applied to the entire area, including “cut” sides. After curing the polyurethane, the bonding agent was applied to polyurethane, and the grooves were filled with micro-silica enhanced, fiber reinforced mortar shown in Figure 9, 10 and 11. The surface the patch was again covered with a thin layer of one-component polyurethane. Delamination repairs varied in depth from 12 mm to 10 cm ($\frac{1}{2}$ to 4 in). The surface of exposed steel was protected by polymer cement based rust-proofing material. The same material was used as a bonding agent for the micro-silica enhanced, fibre reinforced mortar used in filling the delaminated areas, as shown in Figure 12.

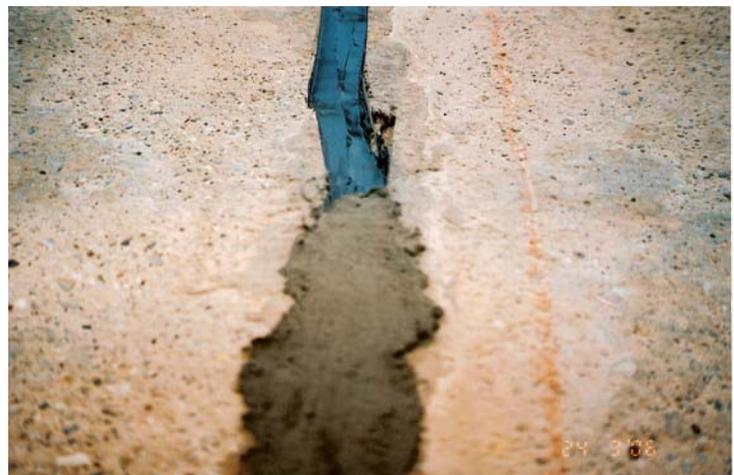
Figure 10. Cracks filled with fibre reinforced mortar bonded with bonding agent to the polyurethane seal

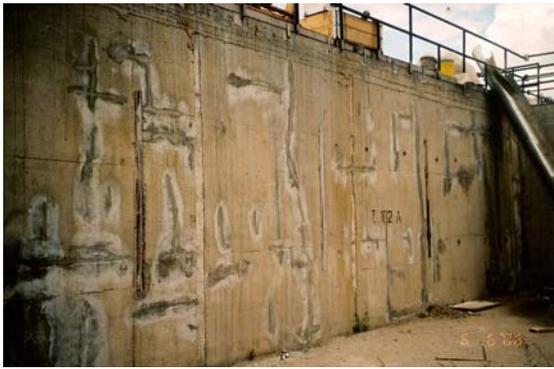
Figure 11. Cracks filled with fibre reinforced mortar bonded with polymer modified cement slurry to the polyurethane seal

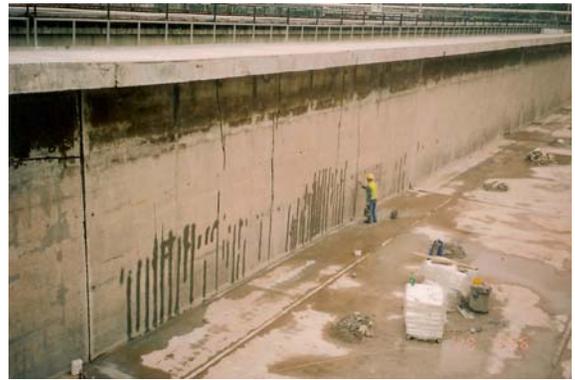
Figure 12. Delamination repairs using fibre reinforced mortar and polymer cement rust-proofing .

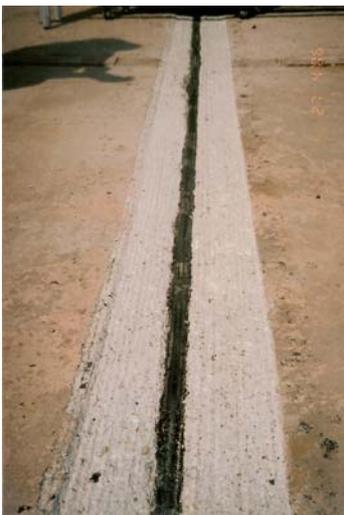
Figure 13: Expansion joint after milling, before placement of the sealant and the rubber sheet.

The original expansion joints were approximately 5 cm (2 in) wide, placed in 50 cm (20 in) thick slab. The original waterproofing was provided by a cast-in concrete water stop. This original treatment failed. Approximately 10 years ago, expansion joints were repaired using a flexible rubber tape, bonded to concrete. All these joint repairs failed again. The repair of the bottom slab joint started with milling off approximately 20 cm (8 in) wide and 12 mm (1/2 in) deep groove over the expansion joint as shown in Figure 13. The expansion joints were cleaned using wet sand-blast and repaired with fibre reinforced mortar, bonded with polymer modified cement slurry. This repair reduced the width of the joint to approximately 4 cm (1 3/4 in). The undamaged existing joint filling material was left in place, and the deteriorated joint filling material was replaced with extruded polystyrene. The 20 cm (8 in) wide area, including vertical sides was coated with one-component polyurethane. This was followed by placement of 2 mm thick layer of oil resistant rubber sheet embedded in to the joint. The joint was then covered with a sheet of stainless steel metal cover mechanically fastened to one side of the joint. The vertical joints were repaired using the same system, as shown in Figure 14.

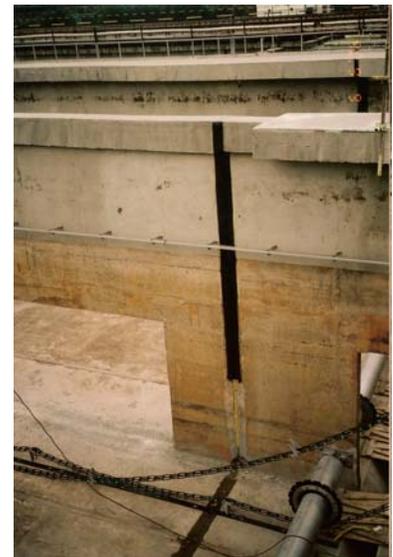
Figure 14. Repair of the vertical expansion joint.

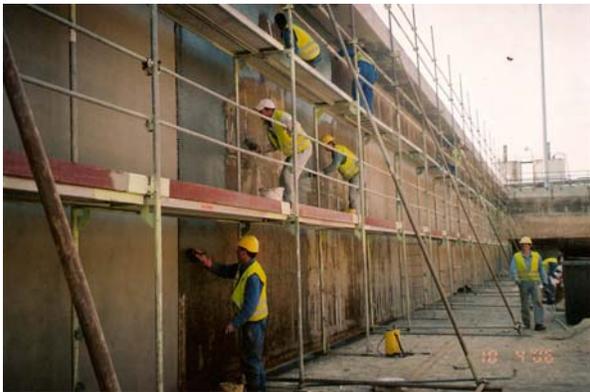
Figure 15. Application of the bonding agent and protective/waterproofing coating.

The polymer modified cement slurry was supplied as a two-component system, consisting of a bag of dry material and a liquid additive. These were thoroughly mixed using an electrical drill and a mortar-mixing paddle into a slurry form. The slurry was brush applied on the surface of concrete, including the polyurethane treated surface of crack repairs. The protective/waterproofing coating was supplied as one component material. It was mixed with water on site and applied by brushing (or spraying and brushing) into the wet bonding slurry of polymer modified cement slurry. The protective/waterproofing coating was applied in two coats to build a layer of total thickness of approximately 3 mm (1/8 in) and wet cured for three days. The application is shown in Figures 15 and 16.

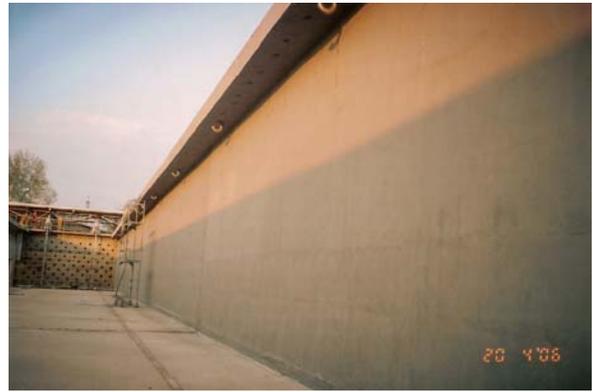
Figure 16. Finished interior of the tank

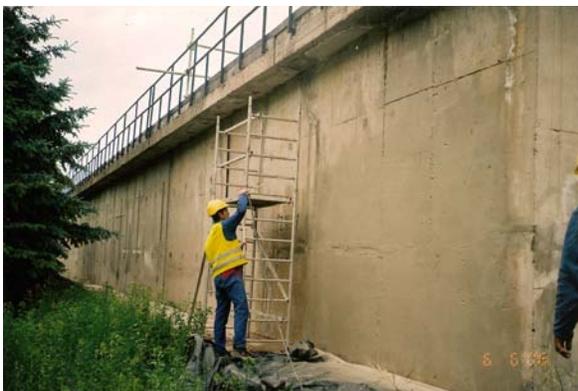
Figure 17. Application of one component polymer modified cement coating to the exterior of the tank

The exterior walls were protected with two coats of one component polymer modified cement coating, approximately 0.5 mm (20 mils) thick, mainly for aesthetic reasons. The coated exterior of the tank is shown in Figures 17 and 18.

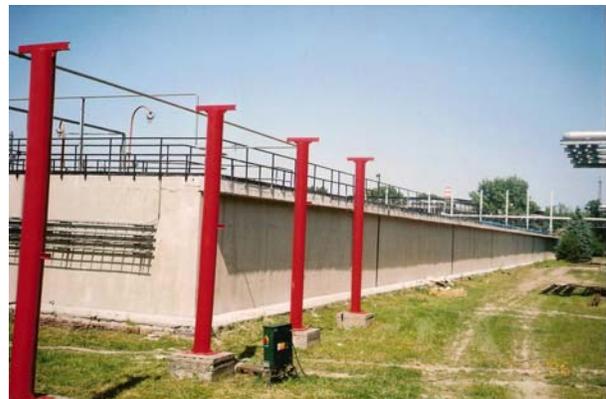
Figure 18. Exterior of the tank after the repair
