# PROJECT PROFILE

**Project:** Chemical storage tank of Blue Ridge Fibreboard Inc. company, Danville, Virginia

**Objective:** Waterproofing and protection of an existing chemical storage tank.

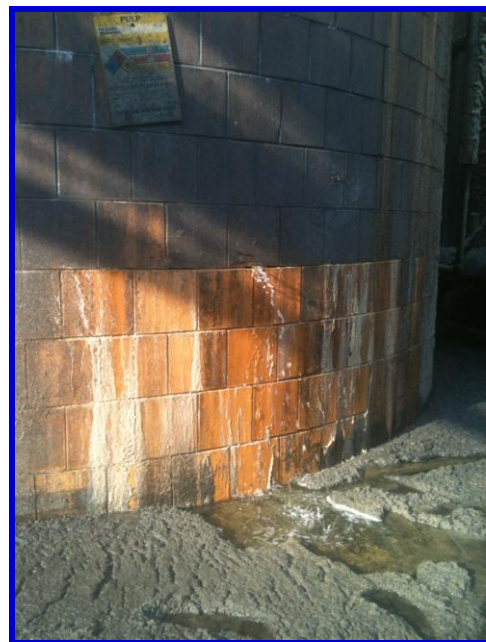
Leaking tank

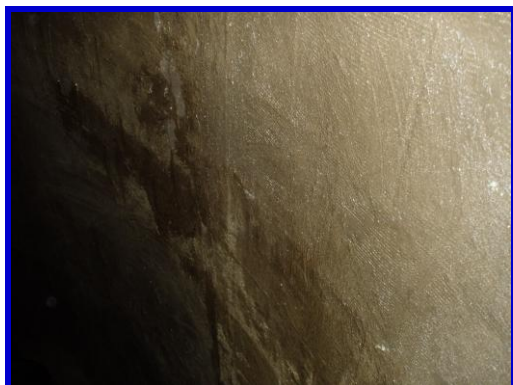
**Interior of the tank during inspection – Cem-Kote Flex CR and the Reinforcing Fabric HD are visible – no deterioration or de-bonding.**
