PROJECT PROFILE

Project: Truro, Nova Scotia
Equalization Tanks, Installation 2011

Gemite products: **Fibre-Prime, Spray-Con WS ST, Cem-Kote Flex CR**

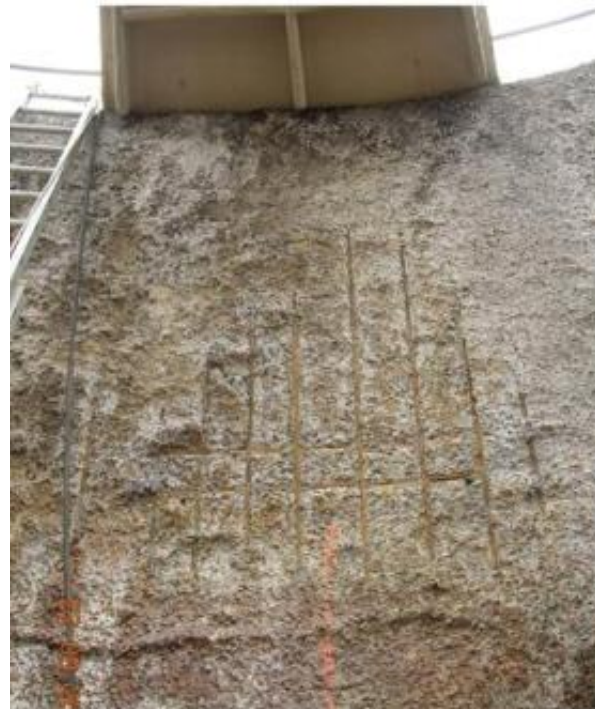
Objective: repair, waterproofing and chemical protection of equalization tank of an industrial facility. The tank is a part of biodegrading facility and is exposed to high levels of hydrogen sulfide. (The information on concrete specification is available on request). The tank was constructed in 1995 with tanks originally not covered. The town expansion resulted in complaints about the smell. For this reason the tank was covered in 2003. There was no deterioration of the tank until then, but since 2003 till 2010, the time of the inspection, there was a serious concrete and the reinforcing steel deterioration as shown in Figure 1 and 2.

Figure 1: concrete deterioration taking place between 2003 and 2010, after the placement of roof in 2003.

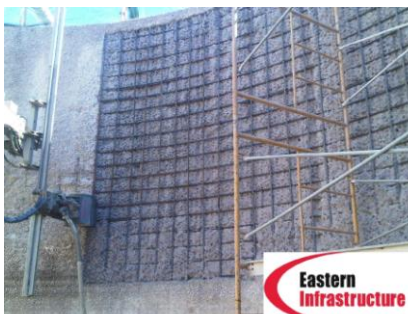
Figure 3 - left: hydro-demolition was used to remove deteriorated concrete, missing reinforcing steel was replaced and all steel treated with Fibre-Prime rust-proofing.

The repair procedure consisted of the following steps: the hydro-demolition removal of deteriorated concrete, (see Figure 3), replacement of deteriorated reinforcement, application of **Fibre-Prime** rust-proofing over all exposed reinforcing steel, wet shotcrete application of **Spray-Con WS ST**, 10-15 cm to repair the concrete surface (see Figure 4 and 5) and application of two coats of **Cem-Kote Flex CR** – waterproofing coating resistant to H₂S. **Spray-Con WS ST** was supplied in concentrate to the ready mix plant and mixed with specified amounts of cement, and aggregate; and supplied in 3 cubic meter quantities to the site for wet process shotcrete application.

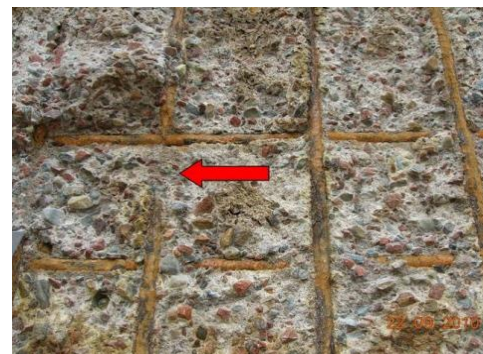
Figure 2 - right: the “top” reinforcing steel in some places was completely corroded

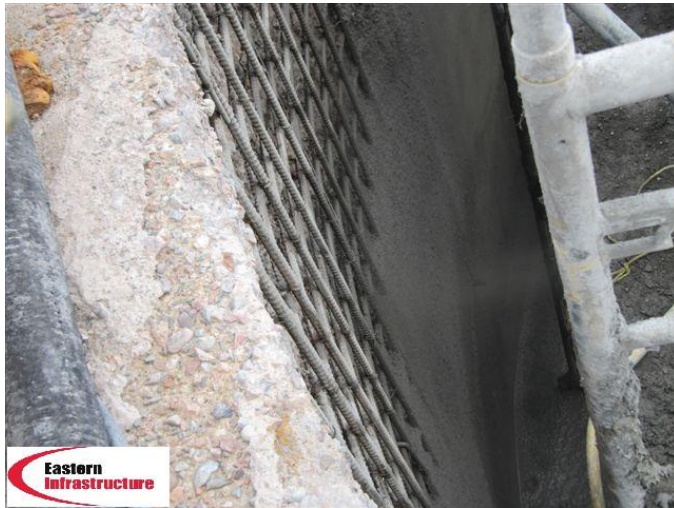
Figure 4. Application of Spray-Con WS ST, wet shotcrete, to repair concrete sections. Spray-Con WS ST was supplied as concentrate, and mixed with cement water and aggregates, according to mix design supplied by Gemite, in the near batch plant. The first batch was 2 cubic meters, the following batches were supplied in mixing truck by 3 cubic meter sizes.

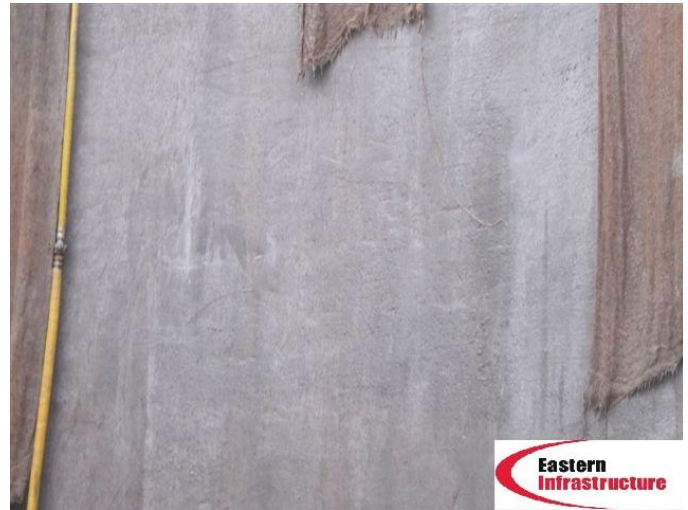
Figure 5: Spray-Con WS ST repair. The entire surface of the tank was coated with Cem-Kote Flex CR within 2-3 days after application of Spray-Con WS ST
