PROJECT PROFILE

**Project: Brantford (Holmedale) Water Treatment Facility
Installation 1998 - Inspection 2011**

Gemite product: Cem-Kote Flex ST

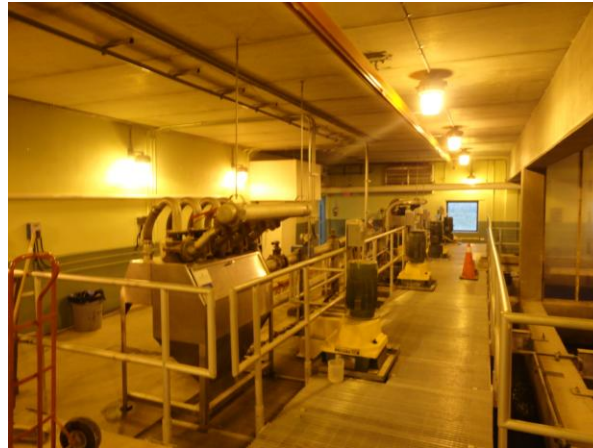
Figure #1: top of tanks showing the sand cleaning and recycling equipment

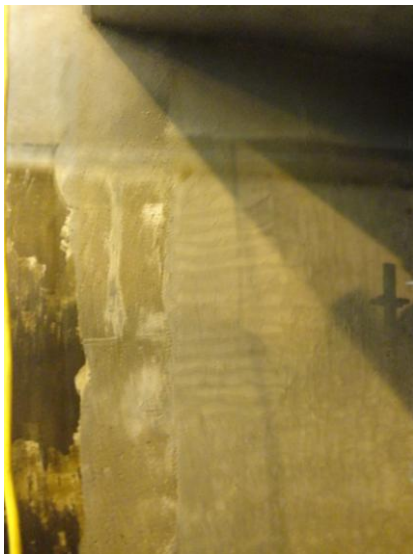
Figure #2: Cem-Kote Flex ST waterproofing applied to exterior wall of the tank #2 and partly on partition wall separating tanks #1 and #2

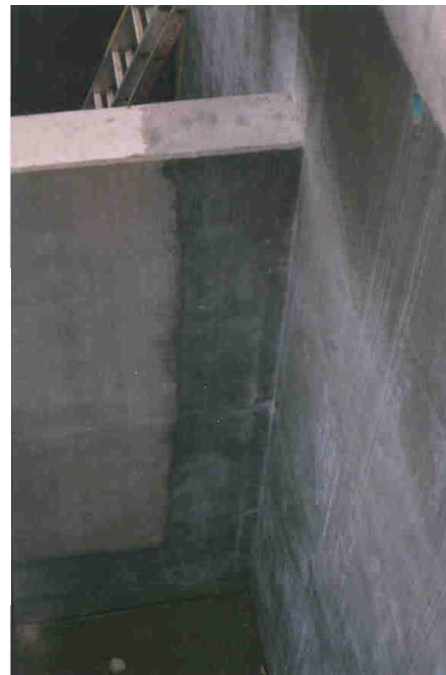
Figure #3. The same as the area shown in Figure #2. The black area to the left is concrete covered with carbonated sludge, in the middle is clean concrete surface and to the right Cem-Flex ST marked by stream of high pressure water.

Flex ST marked by the stream of high pressure water. The surface of concrete and **Cem-Kote Flex ST** was cleaned with 5,000 psi water. The removal of **Cem-Kote Flex ST** requires water pressure exceeding 12,000 psi. In the Tank #3 of the series, the residual sludge is allowed to settle and is scraped from the bottom of the tank. The bottom of the tank as constructed in 1998 is shown in Figure #4. The inspection of **Cem-Kote Flex ST** in this tank is shown in Figure #5. In this case again, in spite of the scraping action at the bottom, **Cem-Kote Flex ST** was undamaged. The removal of **Cem-Kote Flex ST** required pressure in excess of 12,000 psi and the cleaning of **Cem-Kote Flex ST** pressure of 5,000 psi.

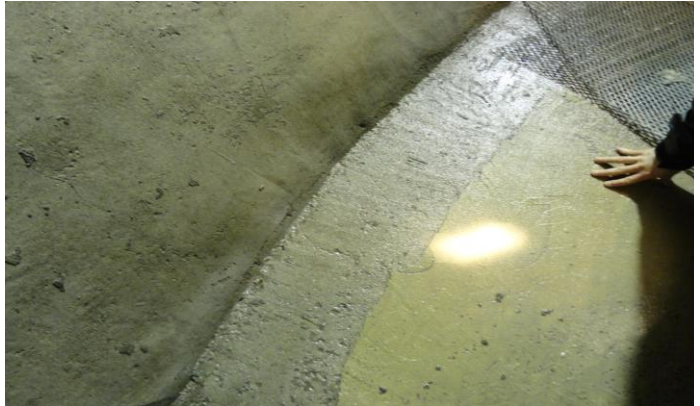
Figure #5: the bottom of the Tank #3. Cleaned Cem-Kote Flex ST to the right, the removal required water pressure in excess of 12,000 psi.

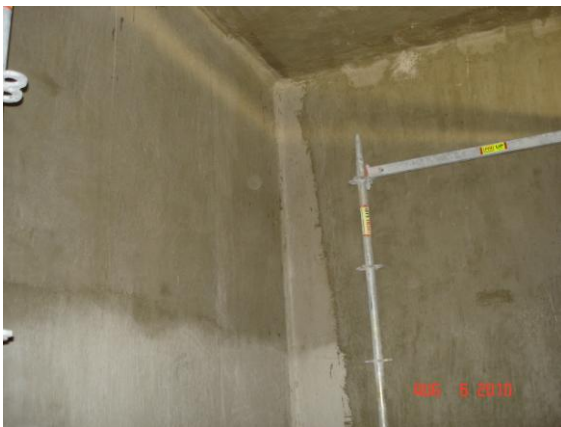
During construction in 2010, the chlorine tanks of the same facility were refurbished and the process changed to ozone treatment. Again, the removal of **Cem-Kote Flex ST** required pressure in excess of 12,000 psi. The refurbished ozone treatment tank are shown in Figures # 6 and 7

Figure 6. Refurbished chlorine treatment tanks to ozone treatment. Initial installation in 1998, modification in 2010

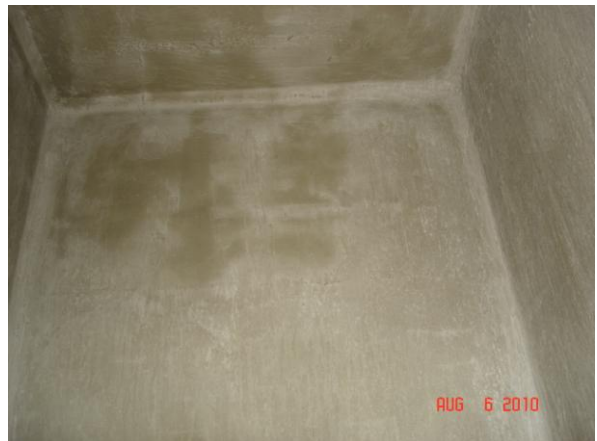
Figure 7. Refurbished chlorine treatment tanks to ozone treatment. Initial installation in 1998, modification in
