Cem-Kote Flex ST

Waste-Water and Potable Water Facilities in Southwestern Ontario

Report

Inspection of Cem-Kote Flex ST performance,
conducted on 15 and 16 August 2005

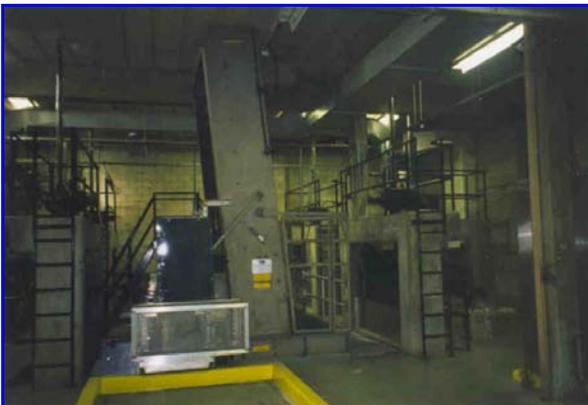
Figure 1: Primary filtration station

The plant was constructed in 1970. Cem-Kote Flex ST was applied in 1993 by London Caulking Ltd. during repairs of the facility. Cem-Kote Flex ST was applied to walls of chambers at the grit removal and screening building (further primary filtration station for short). The primary filtration station is shown in Figure 1. The chambers areas that have been coated with Cem-Kote Flex ST are shown in Figures 2-6. Note deeper chemical and erosion damage to concrete shown at the top of water level area shown in Figure 2. These areas were patched using Gem-Plast TC prior to application of Cem-Kote Flex ST. Figures 4 and 5 show the application of Cem-Kote Flex ST in progress. In addition to the concrete chambers, the reinforced concrete effluent channels leading to the primary settling tanks (further channels), have been also coated with Cem-Kote Flex ST. These are shown in Figures 7-10. These structures carry the wastewater and at this point the flocculent (alum – aluminum sulphate) is introduced in the water stream. In the areas adjacent to the alum entry, the depth of deterioration was approximately ¼ in (6 mm). These areas were repaired with Gem-Plast TC prior to application of Cem-Kote Flex ST. Photo 11 and 12 show high-pressure wash surface preparation.

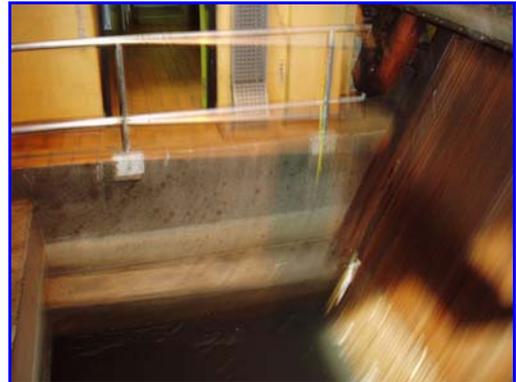
We were able to inspect Cem-Kote Flex ST at the top of the concrete chambers, at the primary filter - Figure 6. There was no visible deterioration or de-bonding of Cem-Kote Flex ST. It must be noted that the area at the water level is most severely exposed due to presence of oxygen and gasses emitted from the wastewater.

Figure 6: Chambers at the primary filtration station – 12 years later – no visible deterioration, cracking or de-bonding of Cem-Kote Flex ST was observed, just some discoloration

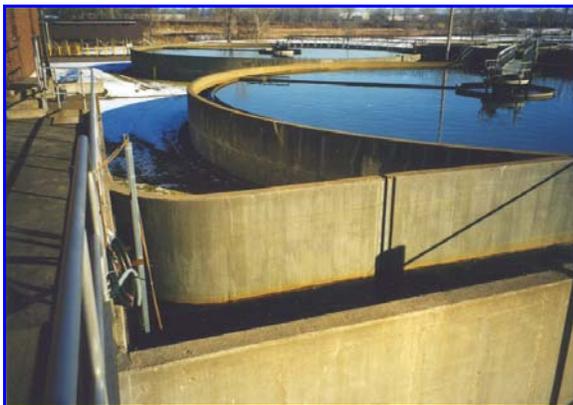
There have been two concrete channels coated with Cem-Kote Flex ST. One of the channels is a “spare” one, which is very rarely used. Figure 7 shows Cem-Kote Flex ST shortly after application in 1993 and Figure 8 shows the same area after 12 years of exposure. Figures 9 and 10 show the channel that is used all the time.

Figure 7: The little used (the “spare”) channel shortly after the application of Cem-Kote Flex ST coating

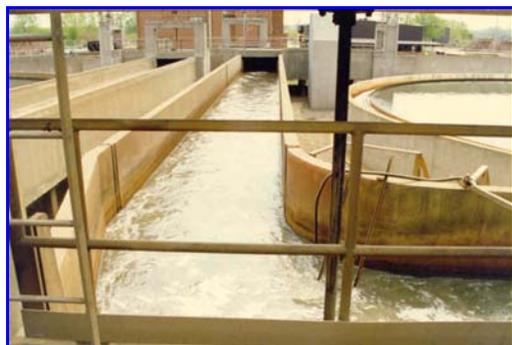
Figure 9: The continuously used channel before the repair – note the rail s where the alum is introduced into the stream – concrete deterioration at this area was approximately ¼ to 3/8 in (6 – 9 mm) deep

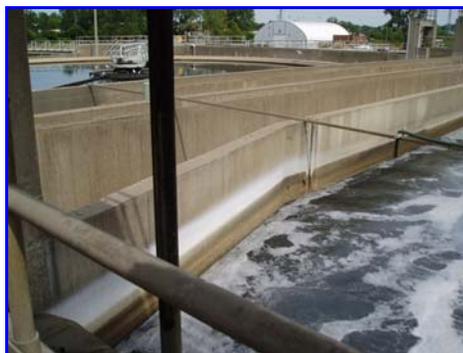
Figure 10: The channel, the same as shown in Figure 9 after 12 years. There is no deterioration, cracking or de-bonding of Cem-Kote Flex ST. Deposits of salts in the area where the alum is discharged form the white discoloration.

This is the “oldest”, the 12 years old, Cem-Kote Flex ST project in South-Eastern Ontario. The inspection has proven an excellent durability, long-term bonding, crack and chemical resistance of Cem-Kote Flex ST in this application.

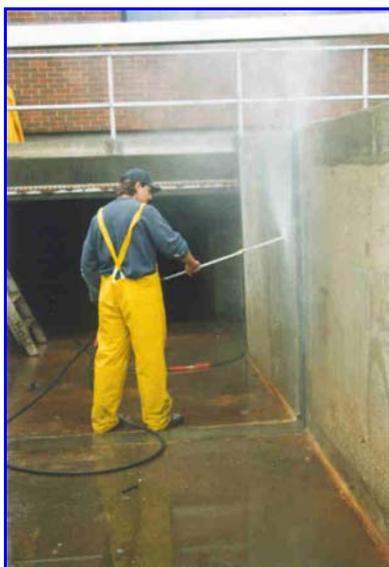
Figure 11: Surface preparation using 3,500 psi (23 MPa) water

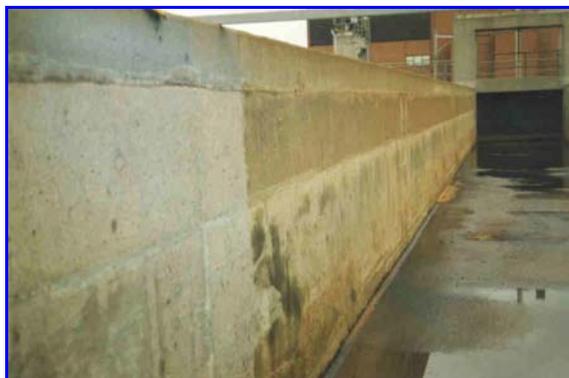
Figure 12: The channel surface after surface preparation, prior to application of Cem-Kote Flex ST

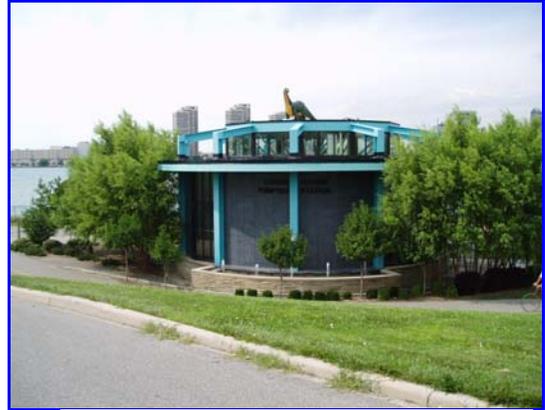
Figure 13: Caron Avenue pumping station

The facility is shown in Figure 13. The main part of the station is a large reinforced concrete tubular well. The concrete well developed some cracking. In 2002 the concrete well was repaired from the negative side using Fibre-Patch WP to stop the active leaks and then Cem-Kote Flex ST was applied to provide the negative side waterproofing. Gem-Cote WA ST – an acrylic water-borne coating was applied to Cem-Kote Flex ST for aesthetic reasons. Cem-Kote Flex ST was installed by London Caulking Ltd.

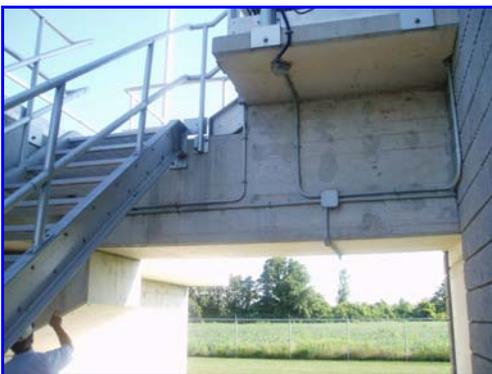
In this facility Cem-Kote Flex ST was applied to grit channels partly shown on Figures 14 and 15 - north and south view respectively. The interior of the channels was coated with Cem-Kote Flex ST to provide a crack resistant waterproofing. Even though the project in terms of Cem-Kote Flex ST application is relatively small; it is

Figure 14: South side view of the grit channel (trough) – no leaks are visible

significant, since it shows after 4 years the resistance to penetration of hairline cracks in the concrete channels. There is no deterioration cracking or de-bonding visible on Cem-Kote Flex ST.

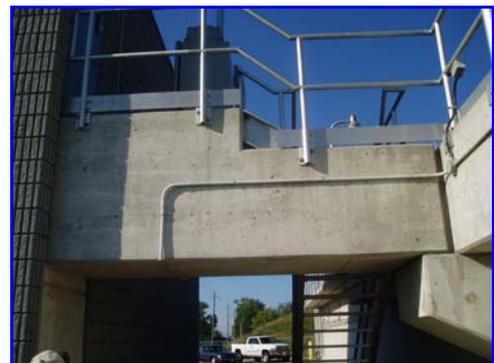
Figure 15: North side view of the grit channel (trough) – no leaks are visible.

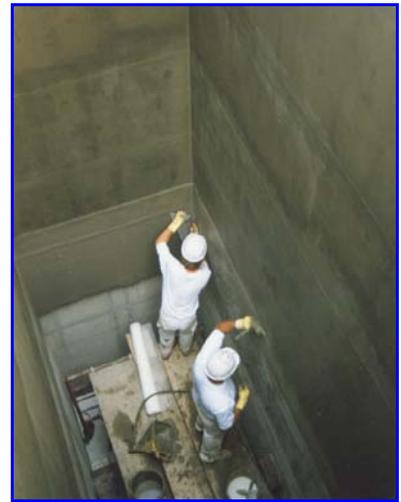
This project has utilized a Cem-Kote Flex ST in several areas. The main areas are the aeration tanks, shown in Figures 18, 19, 20 and 21. One wall of the tanks is also a separation between the mechanical rooms of the facility and the tanks. Application of Cem-Kote Flex ST, including the Reinforcing Fabric HD is shown in Figure 22. The Figures 23 and 24 show the current status in the mechanical tanks. There has never been a penetration of water or leakage into the mechanical rooms from the adjacent tanks.

Figure 22 (right):
Installation of Cem-
Kote Flex ST in the
aeration tanks

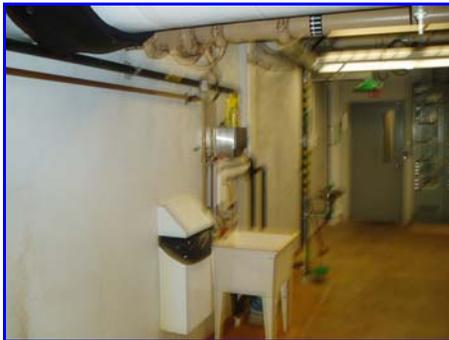
Figure 23: No leaks to the mechanical
rooms. Wall on the left is the wall of the
aeration tanks

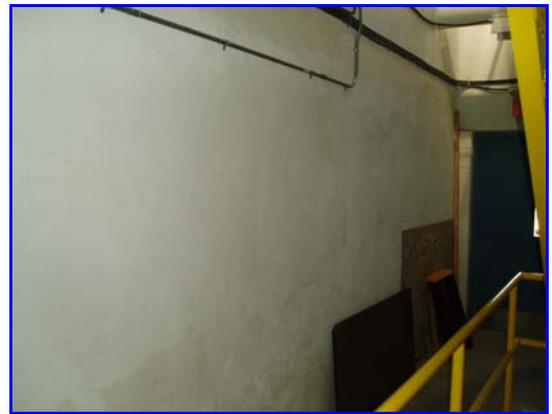
Figure 24: No leaks to the mechanical
rooms. Wall
on the left is the wall of the aeration tanks.

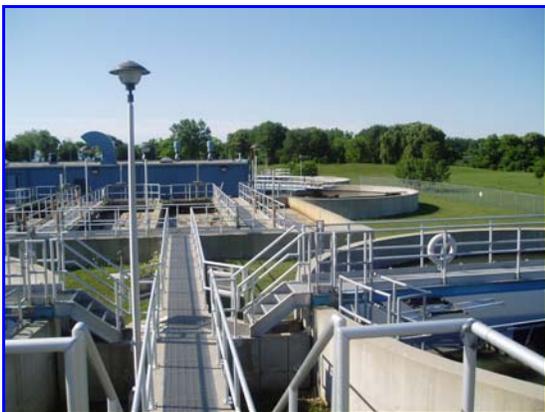
An additional area coated, was the grit channel shown in Figures 25-28. There is no deterioration, de-bonding or cracking in Cem-Kote Flex ST waterproofing liner. The Figures 26 and 28 show the north and south side of the troughs respectively. The concrete trough exhibits drying shrinkage cracking, but there is no water leaking through the cracks indicating, that the Cem-Kote Flex ST waterproofing liner is functioning very well.

Figure 25: A view of the concrete grit channel waterproofed
with Cem-Kote Flex ST reinforced with the Reinforcing Fabric
HD

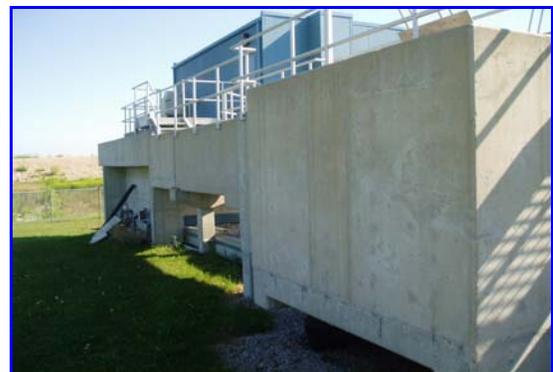
Figure 26: The "south side" view of the grit channel
(trough) at the pump station – no leaks are visible

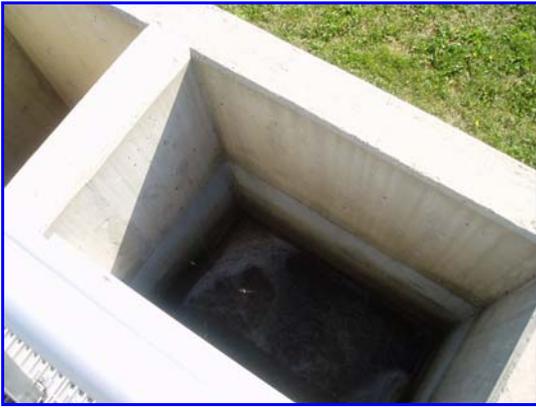
Figure 27: View into the grit channel wells, waterproofed with Cem-Kote Flex ST and reinforced with the Reinforcing Fabric HD. Cem-Kote Flex ST is the light grey material in the well.

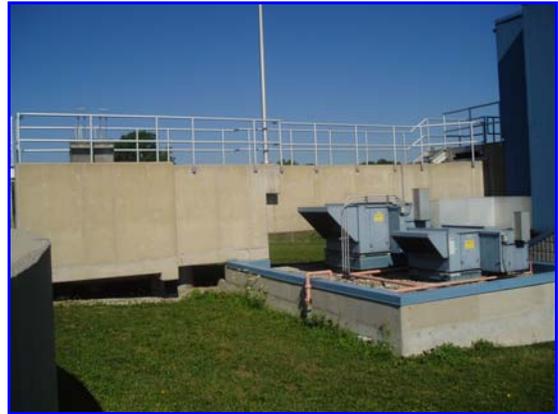
Figure 28: The "north side" view of the grit channel trough) at the pump station – no leaks are visible

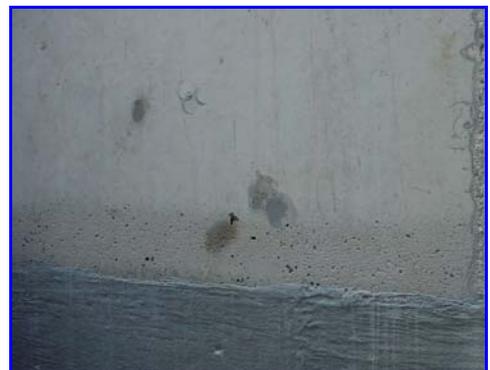
In this project two areas were coated: the grit channel and the clarifiers. Figure 30 shows the Cem-Kote Flex ST coating applied to the concrete surface of the channel, and also shows the surface of concrete after surface preparation with high-pressure water. Figures 31-35 show the current situation of the facility. There is no deterioration, cracking or de-bonding of Cem-Kote Flex ST. The examination of the channel exterior shows no water leaks.

Figure 30: Cem-Kote Flex ST, brush applied – please note the prepared surface after a high-pressure wash, just above the Cem-Kote Flex ST.

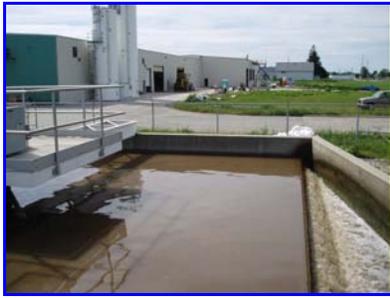
Figure 31: The same area as shown in Figure 29, during inspection in August 2005. No deterioration, delamination or cracking of Cem-Kote Flex ST observed.

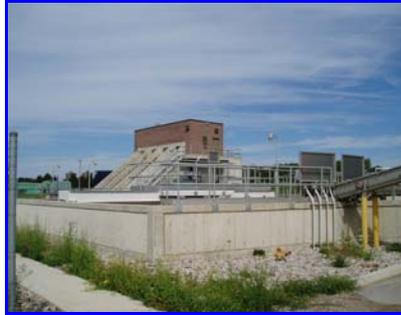
Figure 32: The same tanks as shown in Figures 29, 31 and 33 – outside view. There are no leaks visible in the walls of the tank.

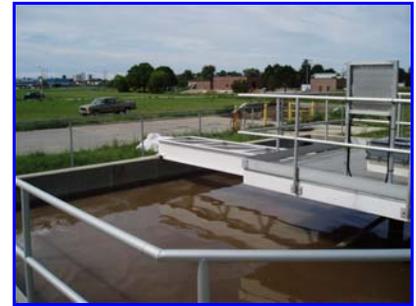
Figure 33: The same tank as shown in Figures 29, 31 32 – a different view – again no deterioration, delamination or cracking of Cem-Kote Flex ST observed,

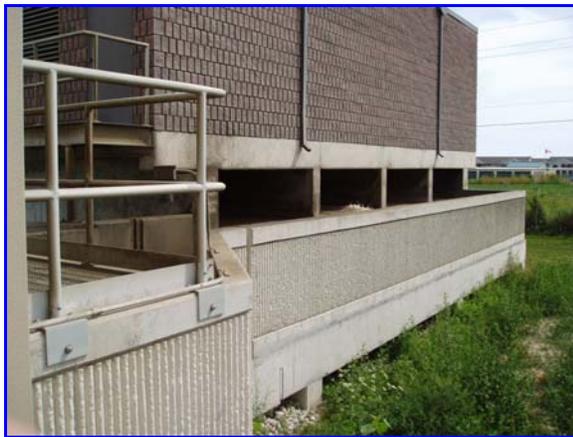
Figure 34: Exterior view of the grit channels after 3year use. No leaking is visible.

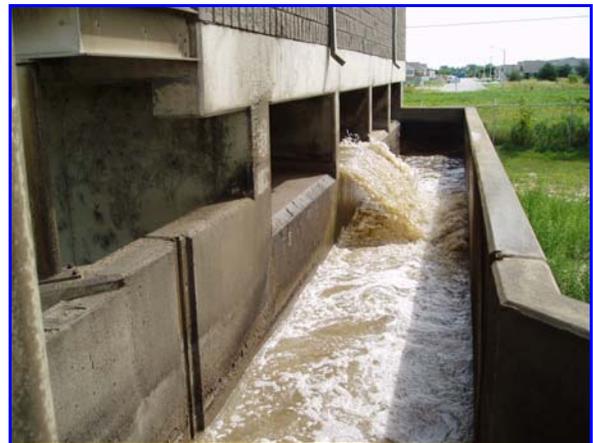
Figure 35: Interior view of the grit channels after 3 years of use. No deterioration due to chemical attack or abrasion, delamination or cracking was observed

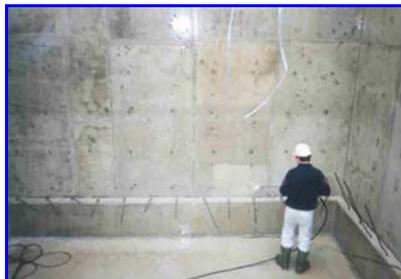
Figure 37: Cleaning the surface of the tanks prior to application of Cem-Kote Flex ST

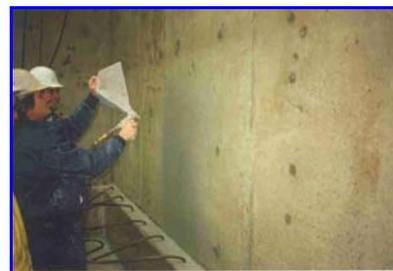
Figure 38: Spray application of Cem-Kote Flex ST. This simple hopper gun equipment for later changed for a more efficient pump.

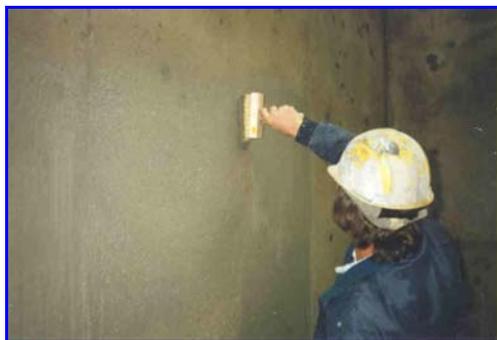
Figure 39: Brushing of Cem-Kote Flex ST to eliminate pinholes.

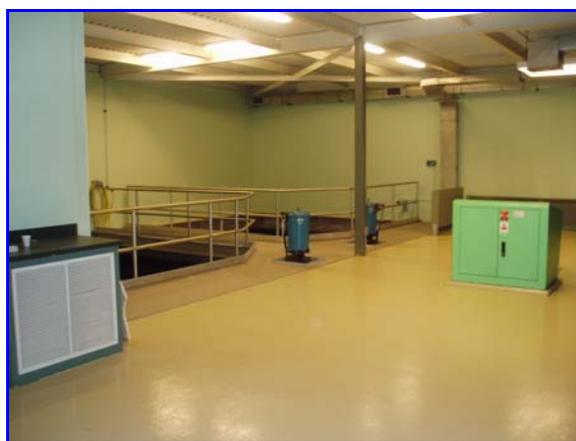
The original tanks were coated with Cem-Kote Flex ST as shown in Figures 37-40. Figure 41 shows the same tanks at the time of inspection in August 2005. Figure 42 shows the exterior sides of the same concrete tanks showing no leaking. The cleaning of the Cem-Kote Flex ST surface, according to the operator, is no different

Figure 41: The tanks constructed in 1998 as they are seen in August 2005

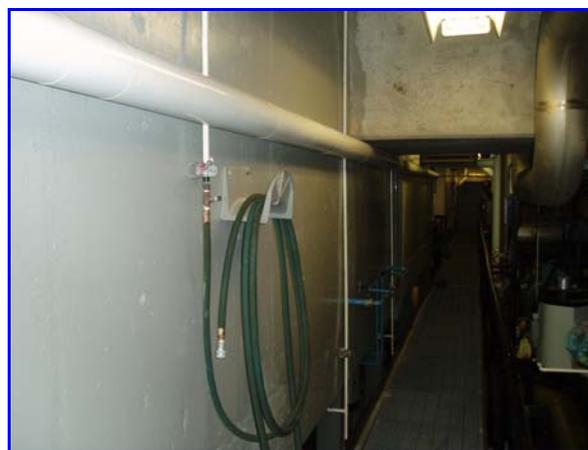
Figure 42: Exterior wall of the tanks – no leaks are visible

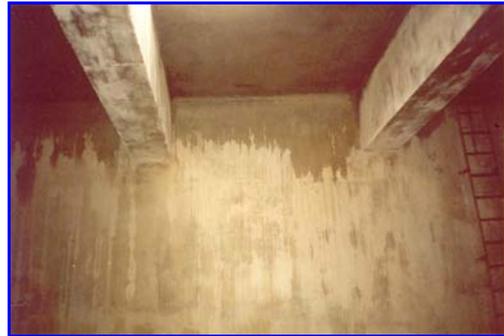
Figure 44: The wall and ceiling was also treated with two coats of Cem-Kote Flex ST.

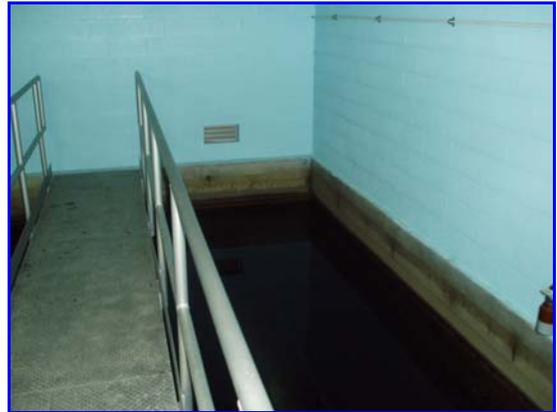
This facility, shown in Figure 45 was built in 1993. At that time Gem-Crete CR, a fiber-reinforced, microsilica enhanced mortar was used in these applications. The original tanks were waterproofed using $\frac{1}{2}$ in (12 mm) thick layer. Figure 46 shows the tanks at present. The inspection of the exterior of the tank walls, Figure 47, shows no leaks. It was confirmed by the operator, Mr. Thomas that the tanks have never leaked.

Figure 46: Fibre-reinforced Gem-Crete CR, $\frac{1}{2}$ in (12 mm) thick, applied to the walls and bottom of several concrete tanks.
