# PROJECT PROFILE

**Project:** Dam repairs, **Korea**

**Designer:** KEPCO (Korean Energy and Power Corporation).

**Gemite product:** **Gem-Crete HDO**

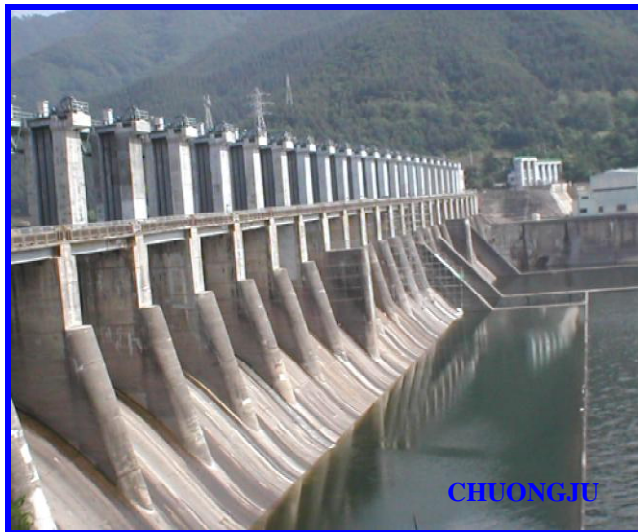
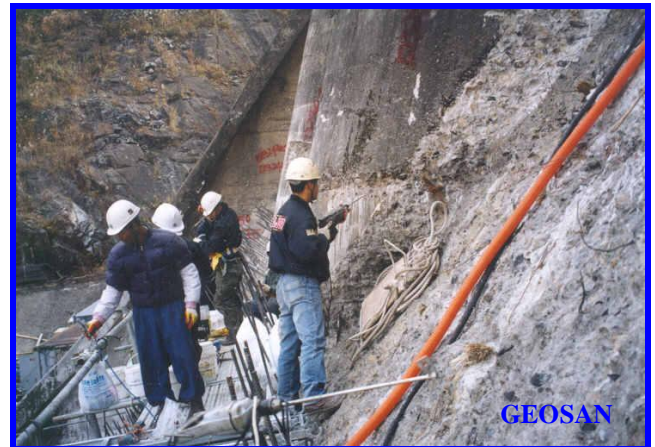
**Objective:** repair deteriorated concrete of the intake areas, spillways and piers of several dams – Geosan, Chuongju and others. The freeze thaw damage of poorly compacted areas were repaired using a high performance fibre cement composite – **Gem-Crete HDO**. The material selected was extensively tested for this application by the U.S. Army Corps of Engineers. It also obtained a special “high tech” certificate in Korea. The thickness of the repairs varied from 1 cm to 10 cm in depth. The material was hand applied after extensive and thorough surface preparation.
